**Report of John J. Datovech, P.E., C.F.E.I.**

**Vermont Mutual Insurance Company,**

**Hamilton Beach / Proctor-Silex, Inc.**

**April 17, 2006**

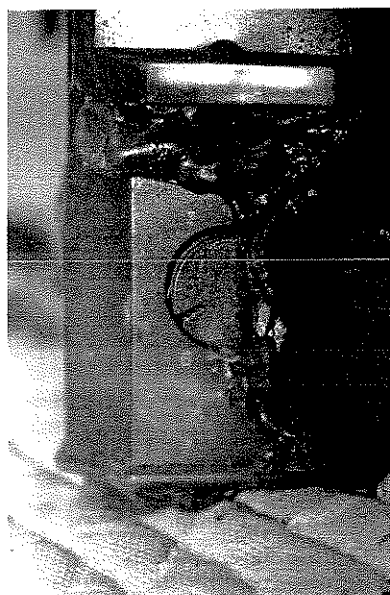
The subject toaster displays a pattern of high-temperature damage consistent with the product being in a fire. The thermoplastic housing is partially melted and burned. The lifter knob is fused into the re-solidified plastic housing in a down position, but it is not completely at the bottom of its travel. The color knob is partially melted and also is fused into the re-solidified plastic housing in a full-dark color setting (see Figure 1).

**Figure 1: Color Control on Full Dark Setting (6 on a scale of 1 to 6)**

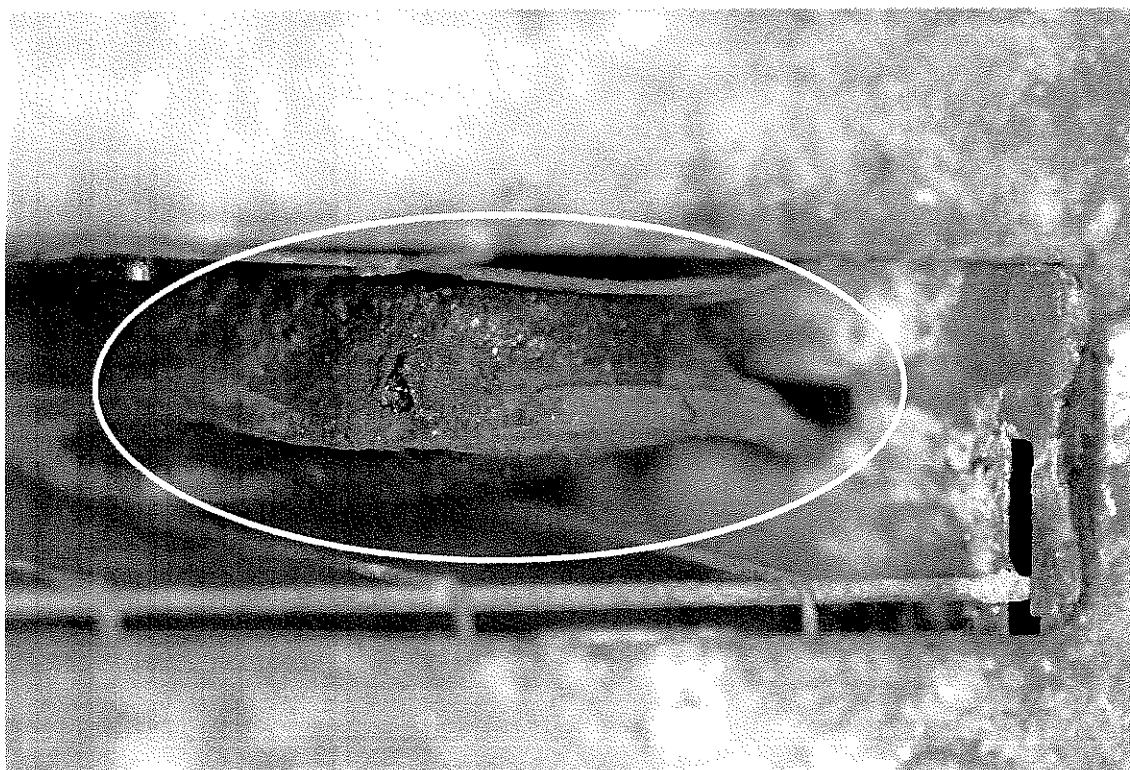
The subject toaster also shows signs of being in use prior to the fire. The remains of a charred, swollen toaster pastry are in the right bread well (see Figure 2).

**Figure 2: Remains of swollen and charred toaster pastry in right bread well**

3. The toaster was being misused prior to the fire.
  - a. The toaster was being used to cook a toaster pastry on the darkest toast color setting.
  - b. The toaster was in use while unattended.
  - c. Both of the above actions directly contradict the instructions provided in the hazard communications supplied with the toaster in both the Use & Care Guide and the separate Drop-In Warning Sheet.

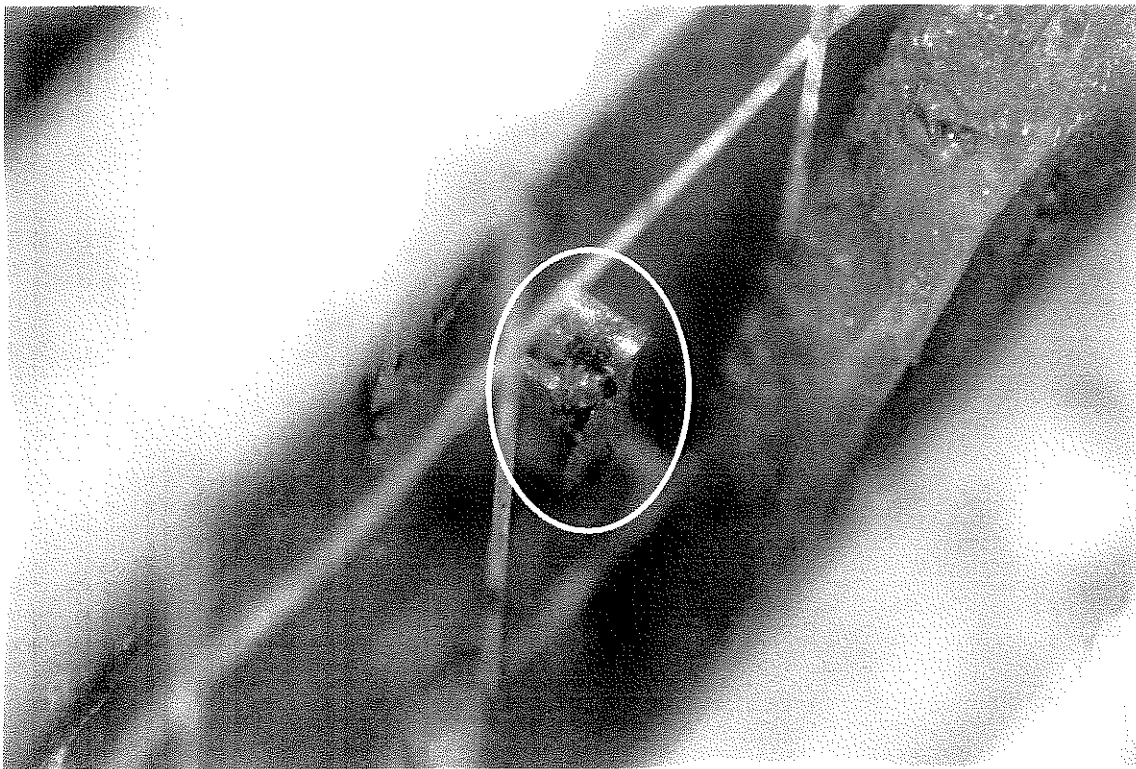
The swollen toaster pastry filled the gap between the grill wires (bread guides). The bimetal of the toaster is warped toward the rear of the toaster, and there is also charred debris on the bimetal of the toaster (see Figure 3).

**Figure 3: Bimetal of toaster covered with charred debris**

- d. The physical evidence indicates the toaster's release system was functioning properly at the time of the fire.
  - i. The bimetal is warped toward the rear of the toaster. This means the bimetal was moving properly under the influence of heat.

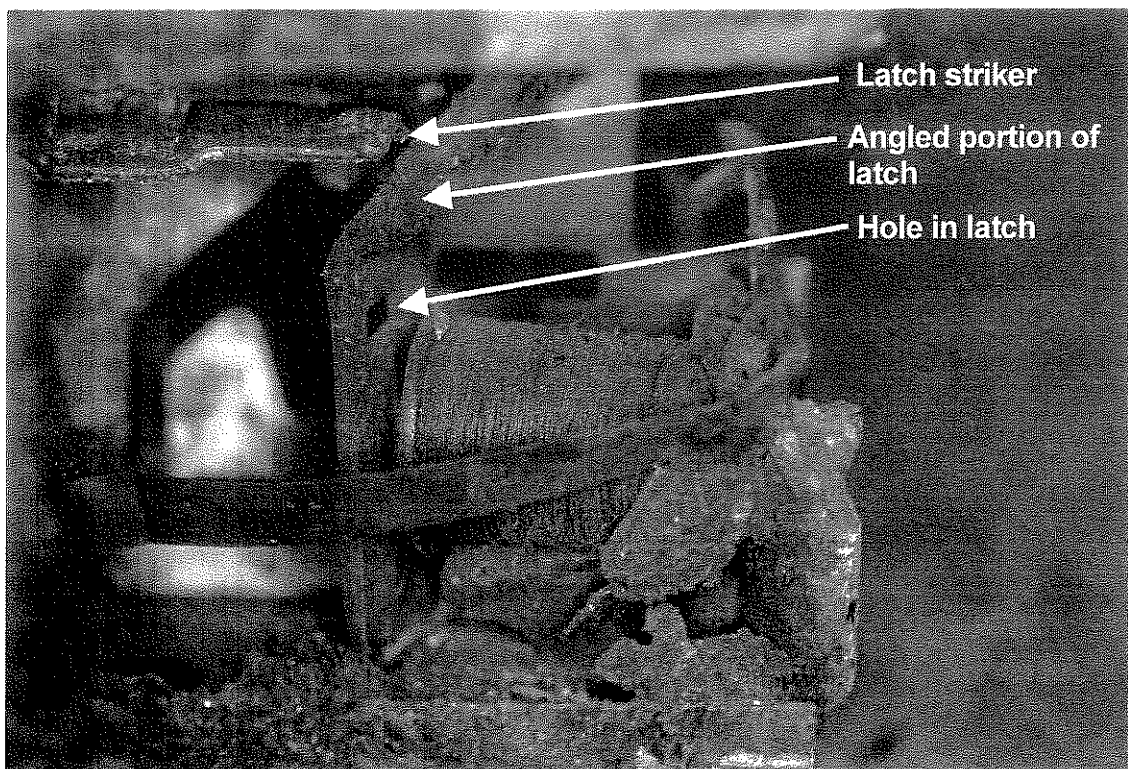
The slide of the toaster is resting towards the bottom of its intended travel, but not all the way at the bottom, latched position. The lifter spring is permanently stretched at the top. The latch striker is resting above the angled top of the latch bar. The latch striker is not engaging the slot in the latch (see Figure 4). The moving contact blades of the line switch are not in contact with the fixed-position contact terminals. X-rays of the toaster indicate no signs of abnormal electrical activity.

**Figure 4: Latch striker resting above the hole in the latch**

- ii. After the fire, the toaster is not in the completely down and latched position. This shows that the latch release and the toaster carriage moved upward. This shows the solenoid was energized, which means the thermal control switch closed. Accordingly, the pusher rod moved to close the switch, which provides further evidence that the bimetal moved under the influence of heat.

c. The actual cause of the stretching damage to the lifter spring in the subject toaster is the heat of the fire. Heat from a fire can anneal the steel in the spring and cause it to anneal. The pull of gravity on the lifter slide will then cause the spring to deform (stretch) as it anneals. Such annealing and collapsing of springs is supported by literature on fire investigation, such as NFPA 921. The steel from which the lifter spring is manufactured will anneal, or lose its tension, around 1100°F to
